Commission Report

Stage 3 - Fire Hydrant System Upgrade

Site: Stage 2 - St Francis Assisi House, Aged Care Facility

Report Number: 14092

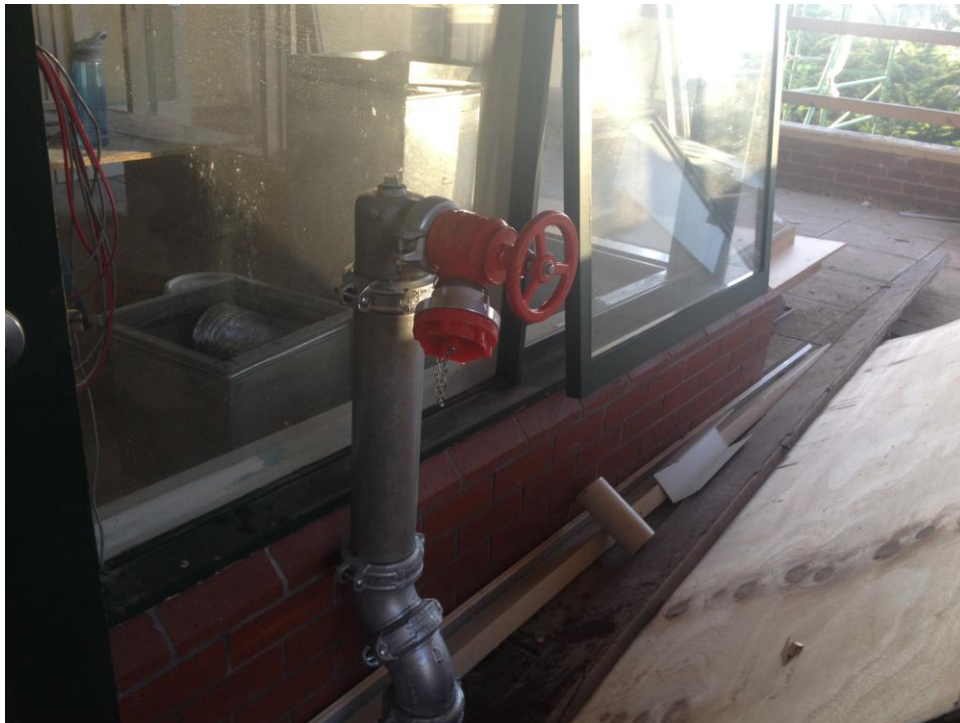
6. Fire Hydrant Pressure & Flow results:

The static pressure recorded was: 690 kPa

The residual pressure of the upgraded Stage 3, Most Disadvantaged fire Hydrant (MDH) was: 480 kPa

MDH located: On level 1 on the south / east corner of the new addition to the building.

The results indicate that when tested through a single head fire hydrant riser the required pressure (350 kPa) and flow was achieved (10 L/s).

The flow test was recorded using a 22mm nozzle outlet.

The residual pressure and flow recorded was 480kPa @ 11.7 L/s in accordance with AS 2419.1 2005

Comments: Passed

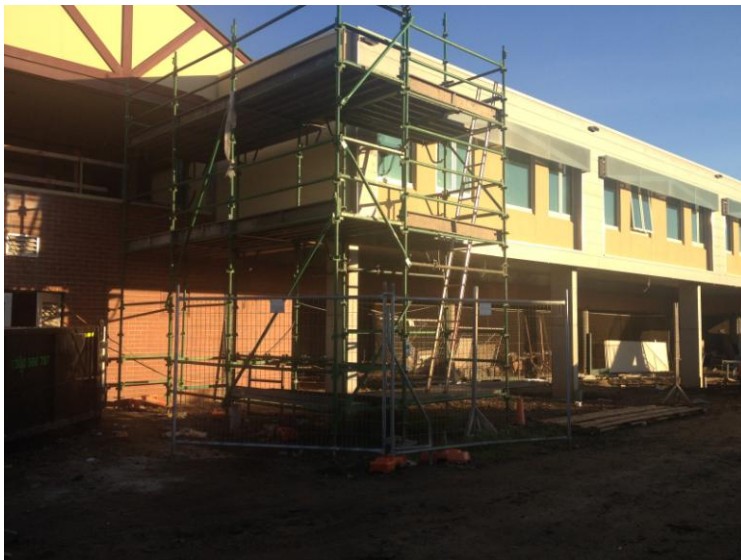
Note: Final Stage [3] of the Building is still under construction
